**MULTI-MEDIA COMPLIANCE EVALUATION INSPECTION
U.S. ENVIRONMENTAL PROTECTION AGENCY
REGION III
OFFICE OF ENFORCEMENT, COMPLIANCE, & ENVIRONMENTAL JUSTICE**

**American Zinc Recycling Corporation
(formerly Horsehead Corporation)
900 Delaware Ave
Palmerton, Pennsylvania 18071**

Inspection Dates: 14-18 May 2018

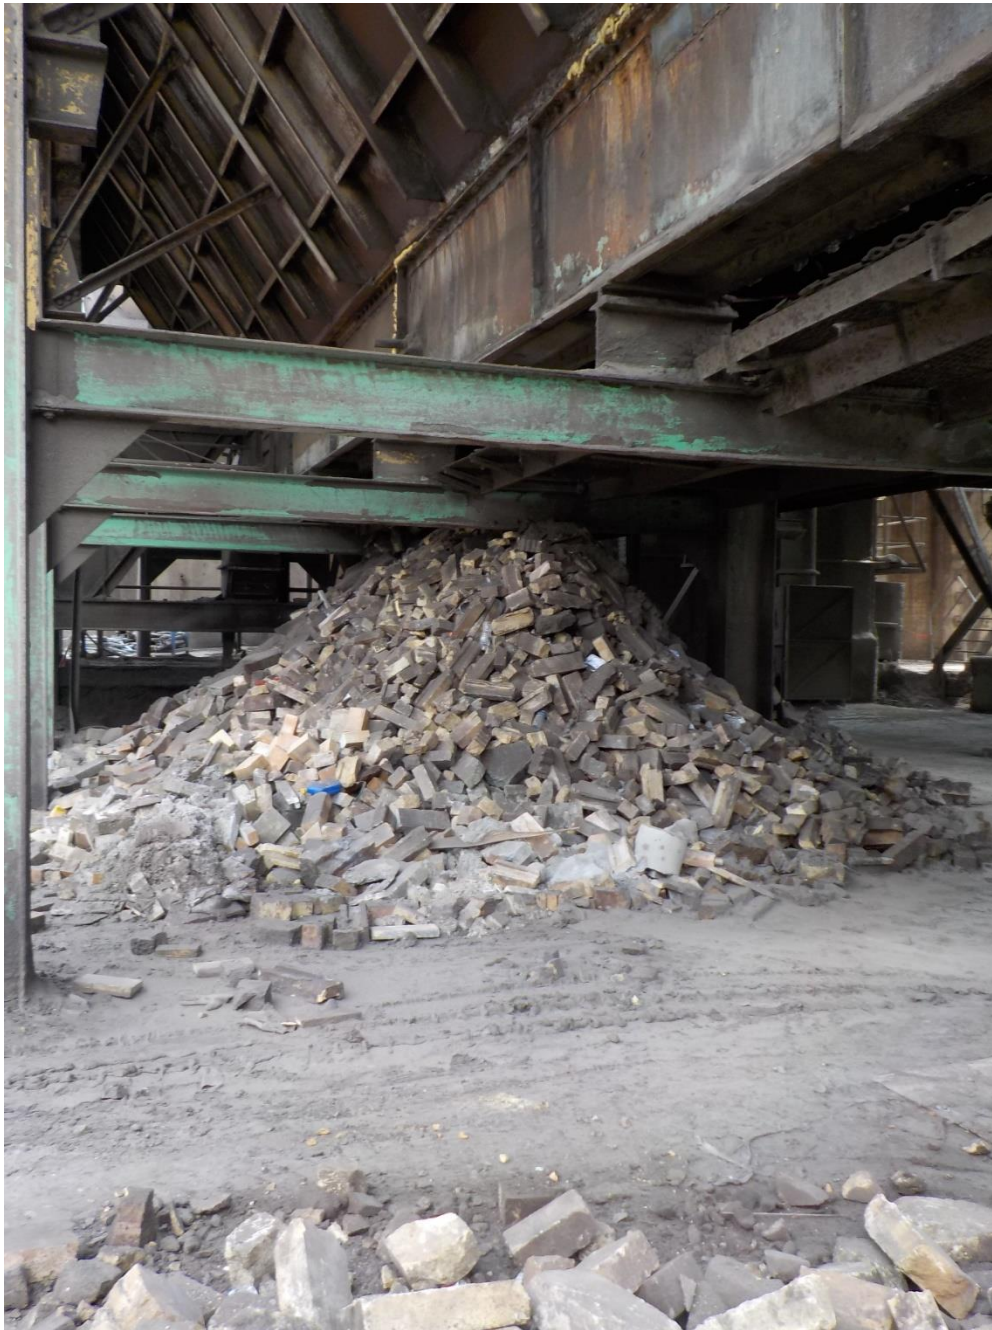
Photo 90. (DSCN0258) This photo shows a pile of kiln brick waste near Kiln 5. See also Photo 91.

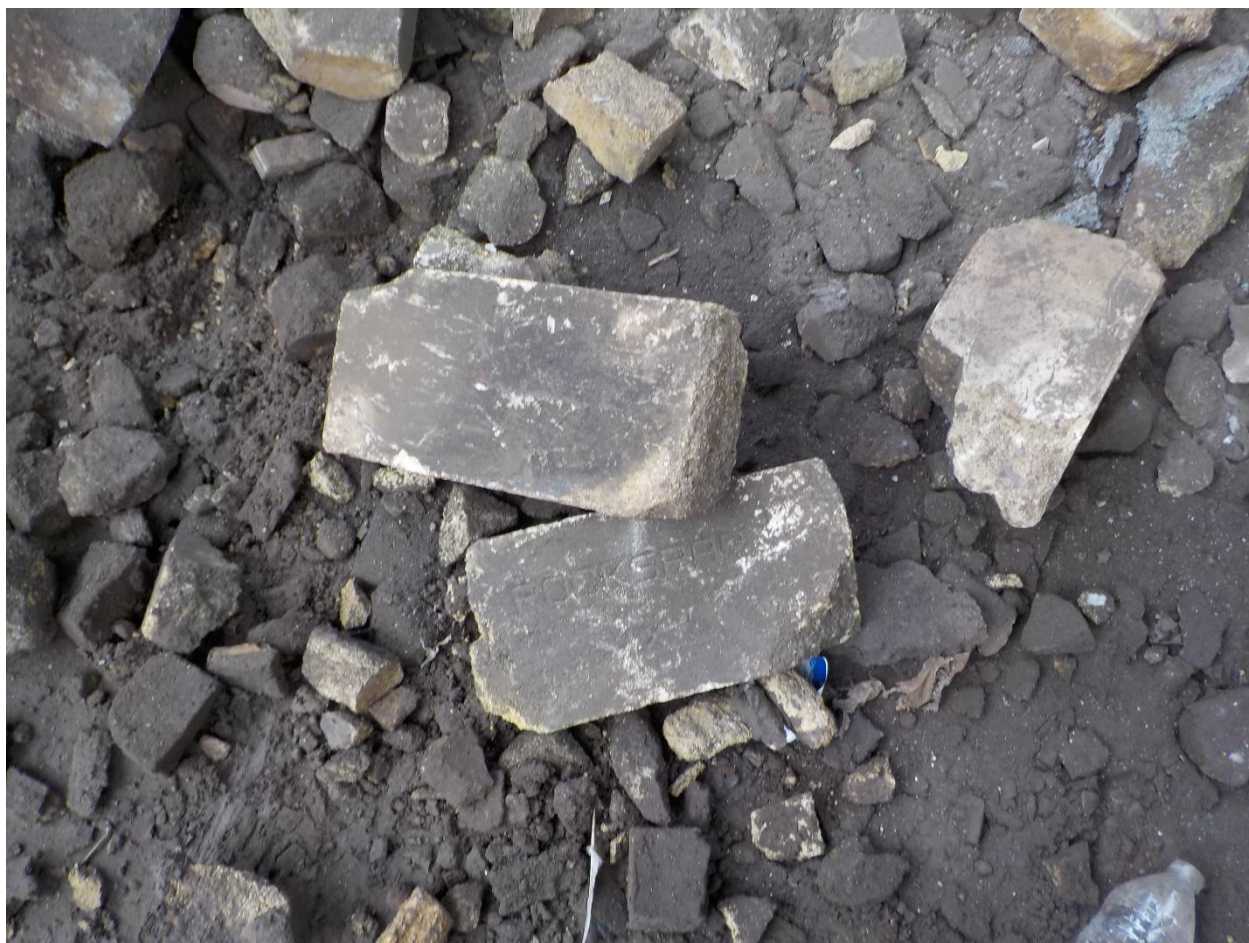
Photo 91. (DSCN0257) This photo shows a close-up of kiln brick waste on the ground near Kiln 5. See also Photo 90.

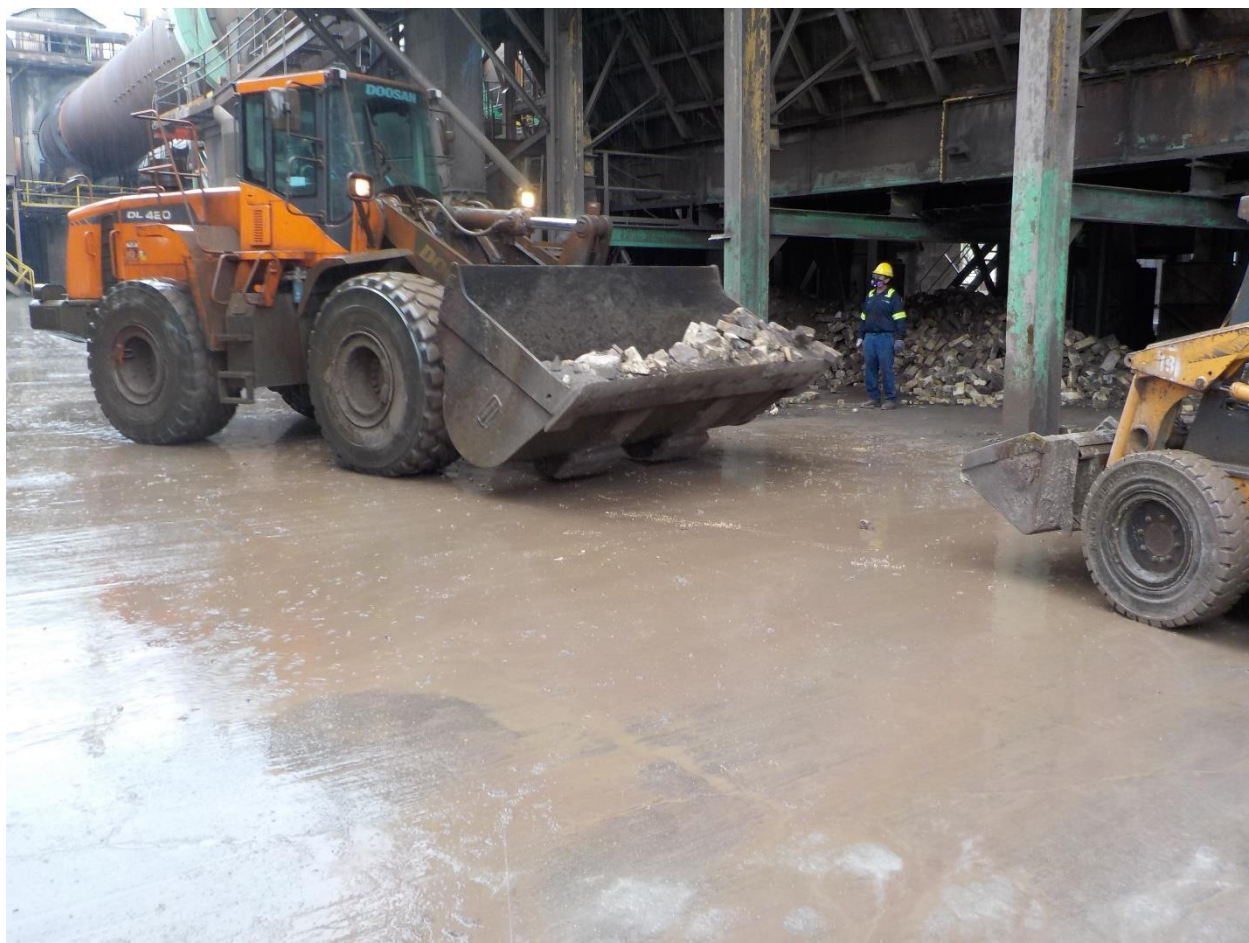
Photo 93. (DSCN0323) This photo, taken during wet weather on 16 May, 2018, shows a payloader moving kiln brick waste from a pile underneath Kiln 5.

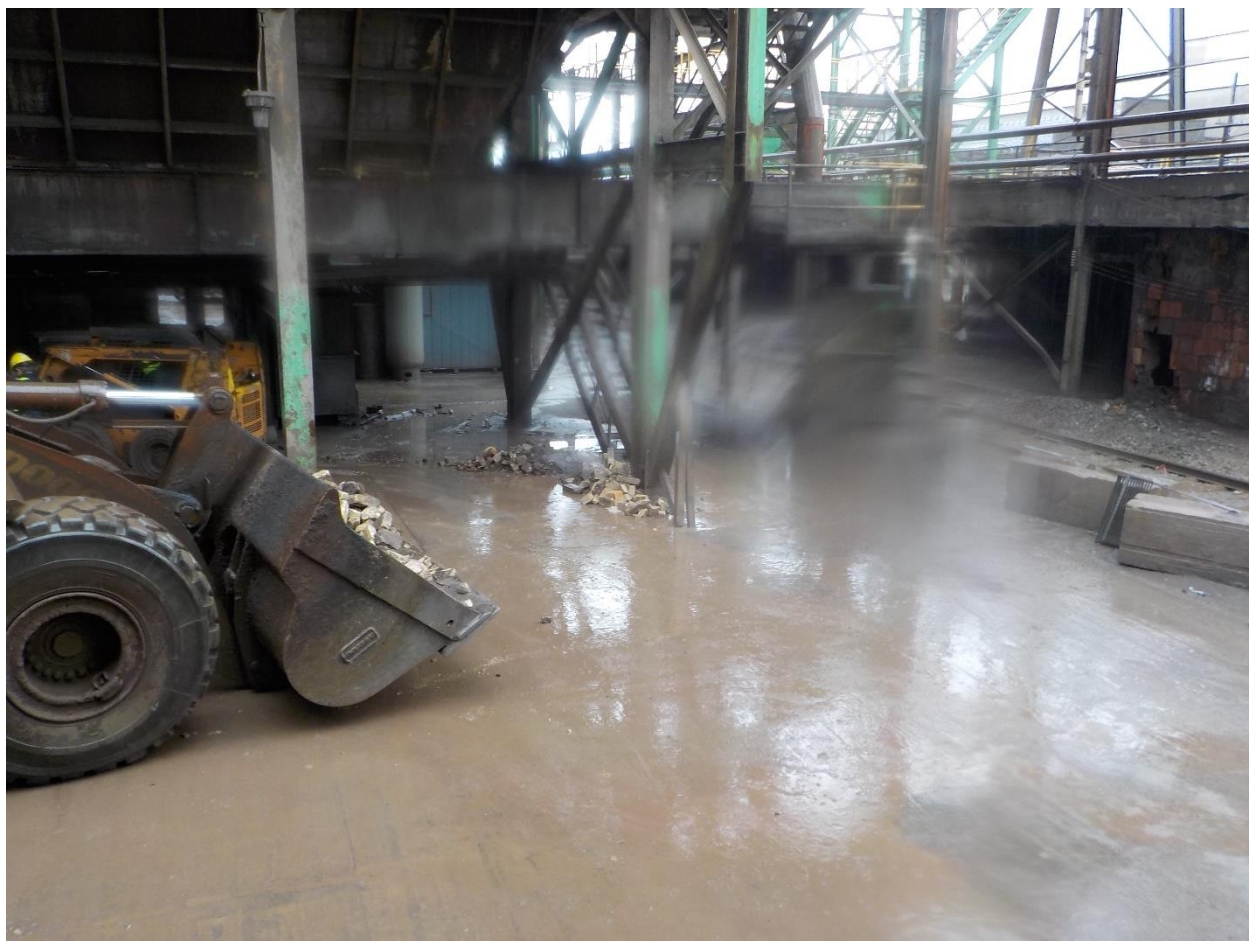
Photo 94. (DSCN0329) This photo, taken from a catwalk on the west side of Kiln 6 during wet weather on 16 May, 2018, shows part of the paved area between Kiln 5 and Kiln 6. Visible in the background is kiln brick waste on the pavement. Storm water drainage is generally from left (south) to right (north) in this photo. Note that storm water runoff is coming into contact with the kiln brick waste.

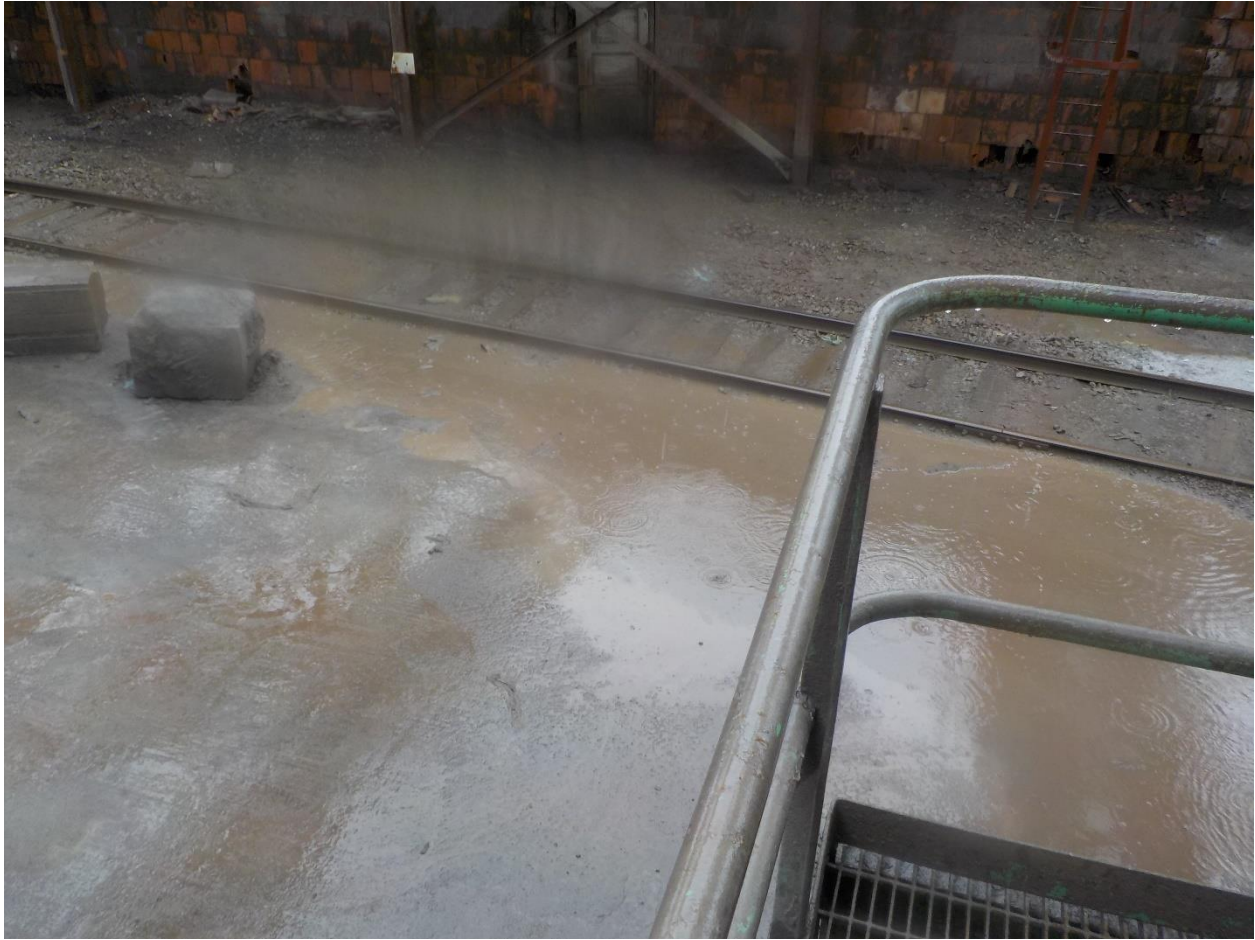
Photo 95. (DSCN0328) This photo, taken a catwalk on the west side of Kiln 6, looks northward to the railroad bed. Storm water runoff, discolored brown with fine suspended sediment, is moving northward over impervious surface and pooling on the south side of the tracks. Storm water pools extend west along the tracks, where some storm water disappears rapidly into the railroad bed. See also Photo 96 [Video].

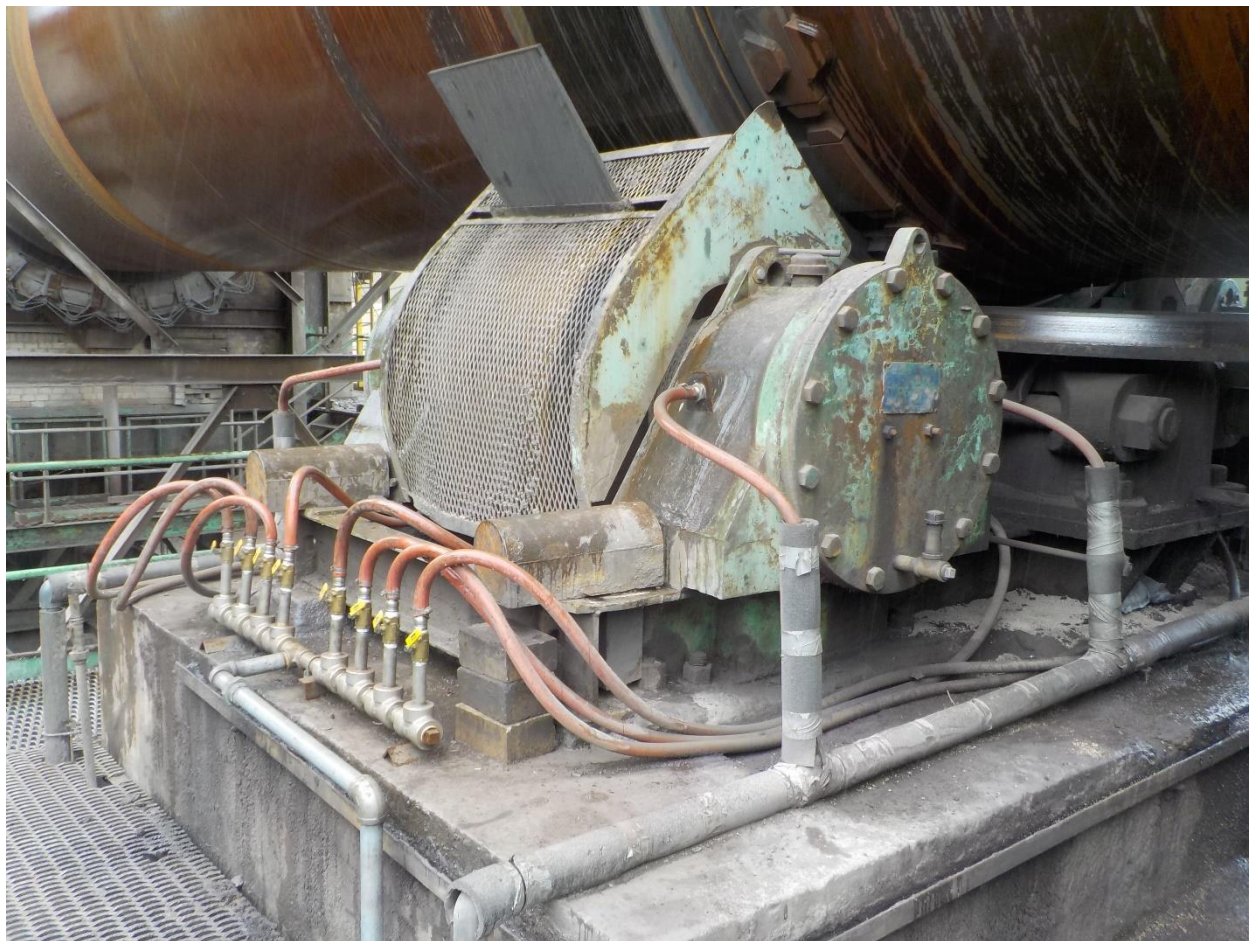
Photo 97. (DSCN0318) This photo, taken on Kiln 6, shows one of rotary kiln bearings and the manifold which distributes non-contact cooling water to the bearing, Note, the return flow pipe is also visible at the bottom of this photo. See also Photo 98.

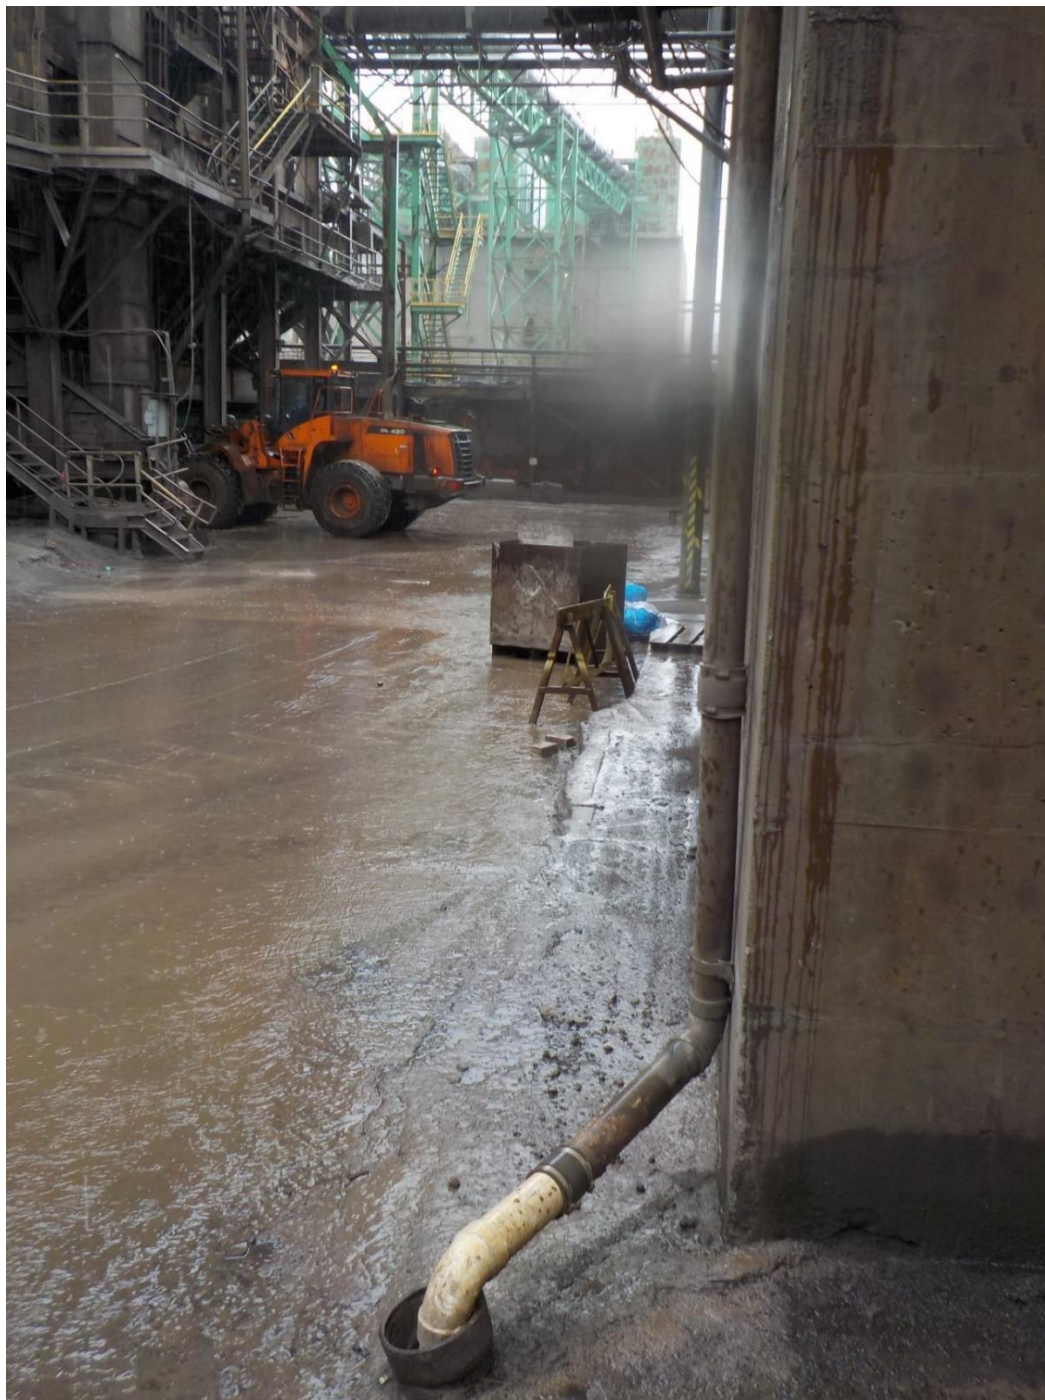
Photo 98. (DSCN0321) This photo shows the return flow pipe of NCCW from a Kiln 6 bearing, going underground.

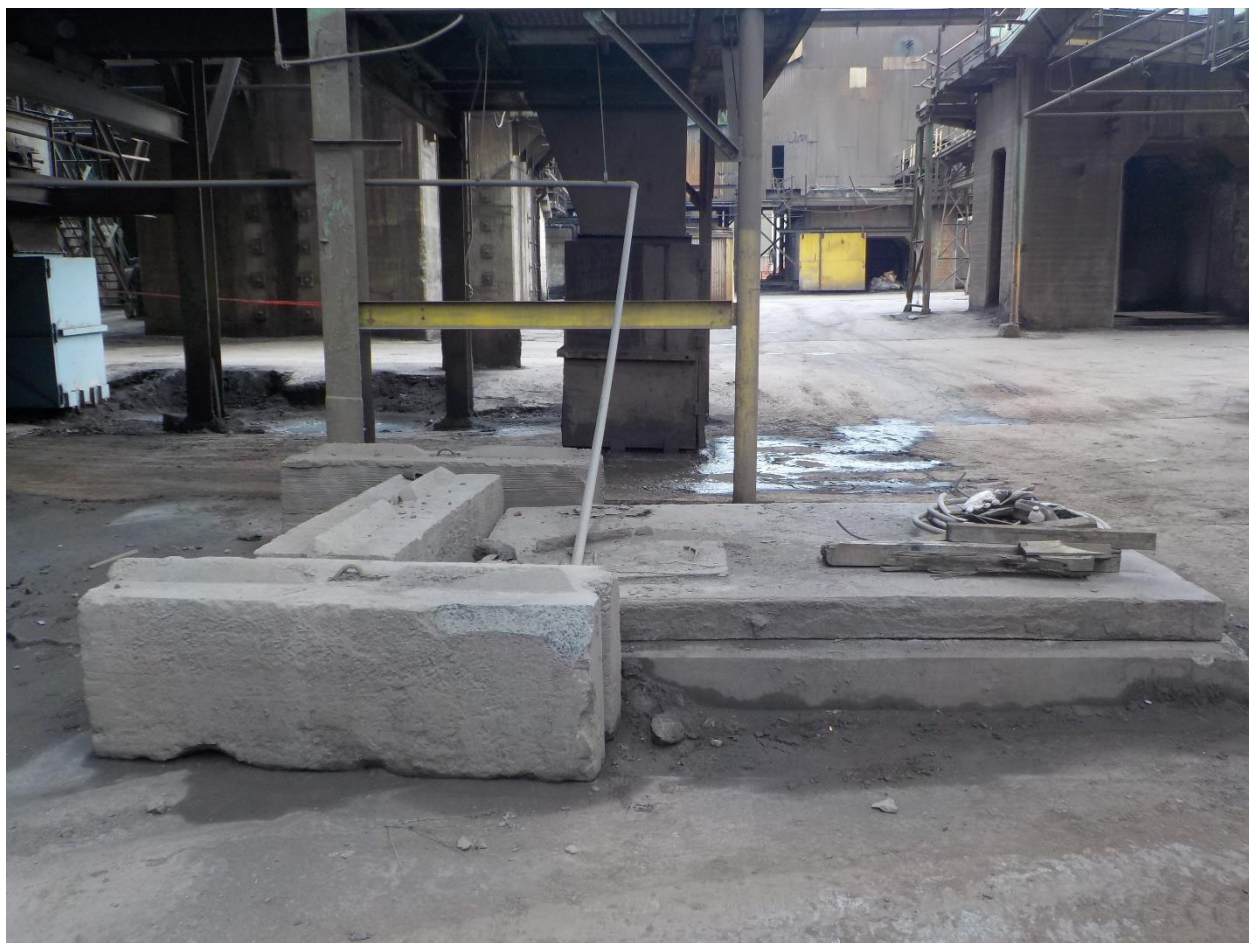
Photo 99. (DSCN0285) This photo looks southward between Kiln 2 and former Kiln 3, at a concrete “sump” (designated by EPA inspectors as “sump 13”). Note the pipe that comes laterally off Kiln 2 at left, then turns downward at a 45 degree angle and enters the sump. See also Photos 100, 101, and 102.

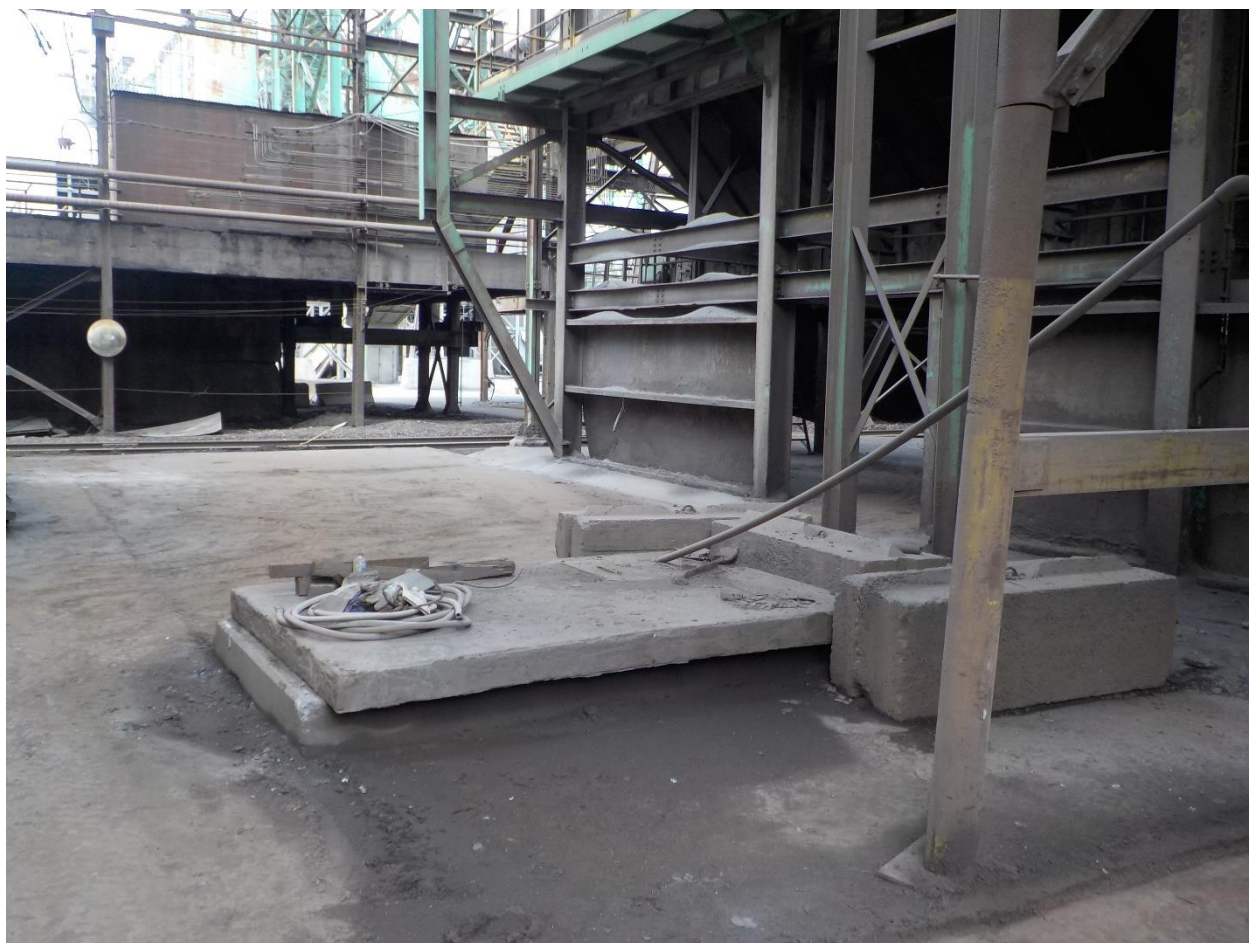
Photo 100. (DSCN0280) This photo looks northward between Kiln 2 and former Kiln 3. The concrete feature in the middle ground of this photo is “sump 13.” Note the pipe coming from Kiln 2 at right enters the sump. Note also the presence of gray or black sedimentary material accumulated on the paved surface around the sump, and piles of gray, fine-grained material on the Kiln 2 beams in the background. See also Photos 101 and 102.

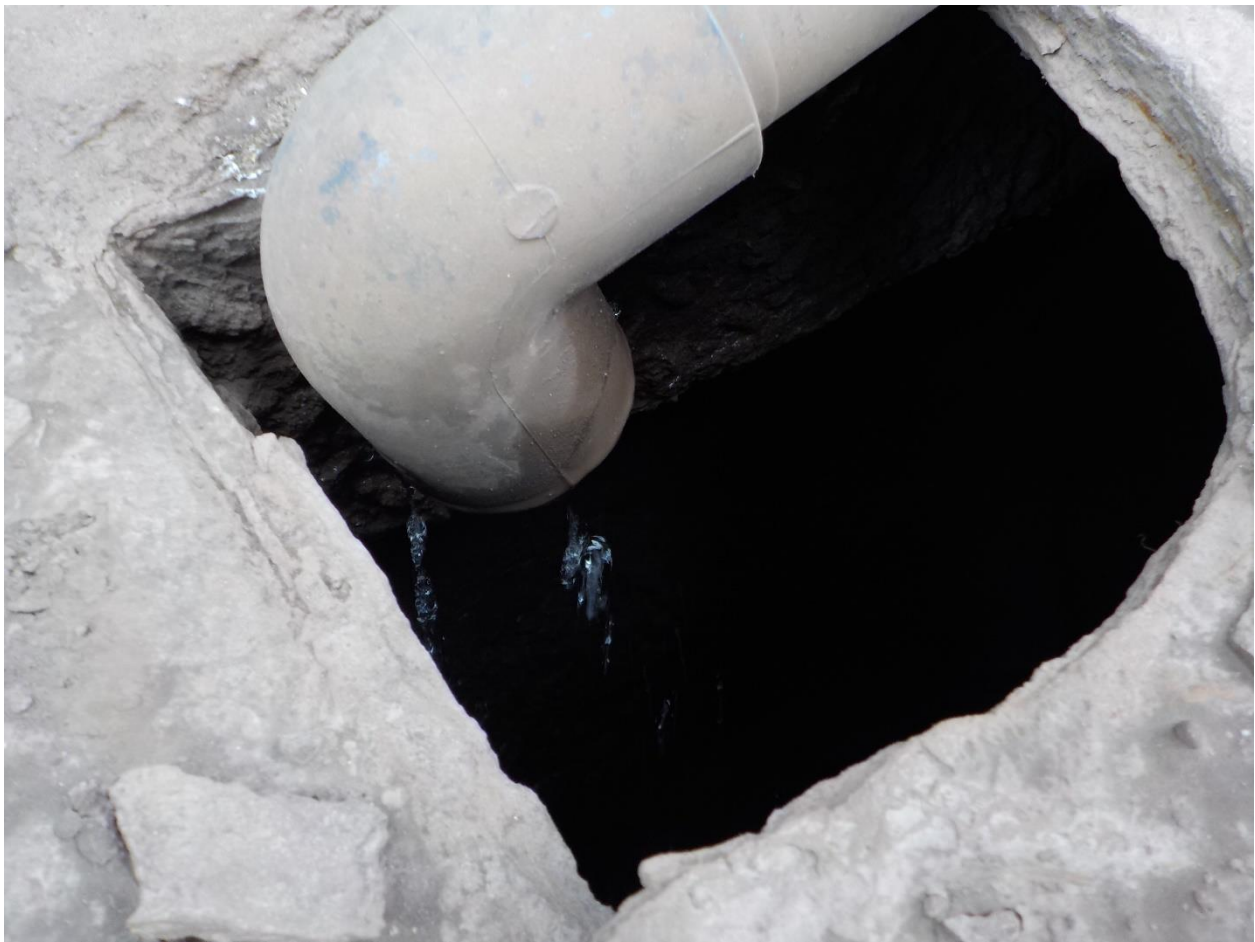
Photo 101. (DSCN0282) This photo shows a close up of the pipe entering the sump, designated by EPA inspectors as feature “13,” through a hole in the concrete lid. See also Photos 99, 100, and 102.

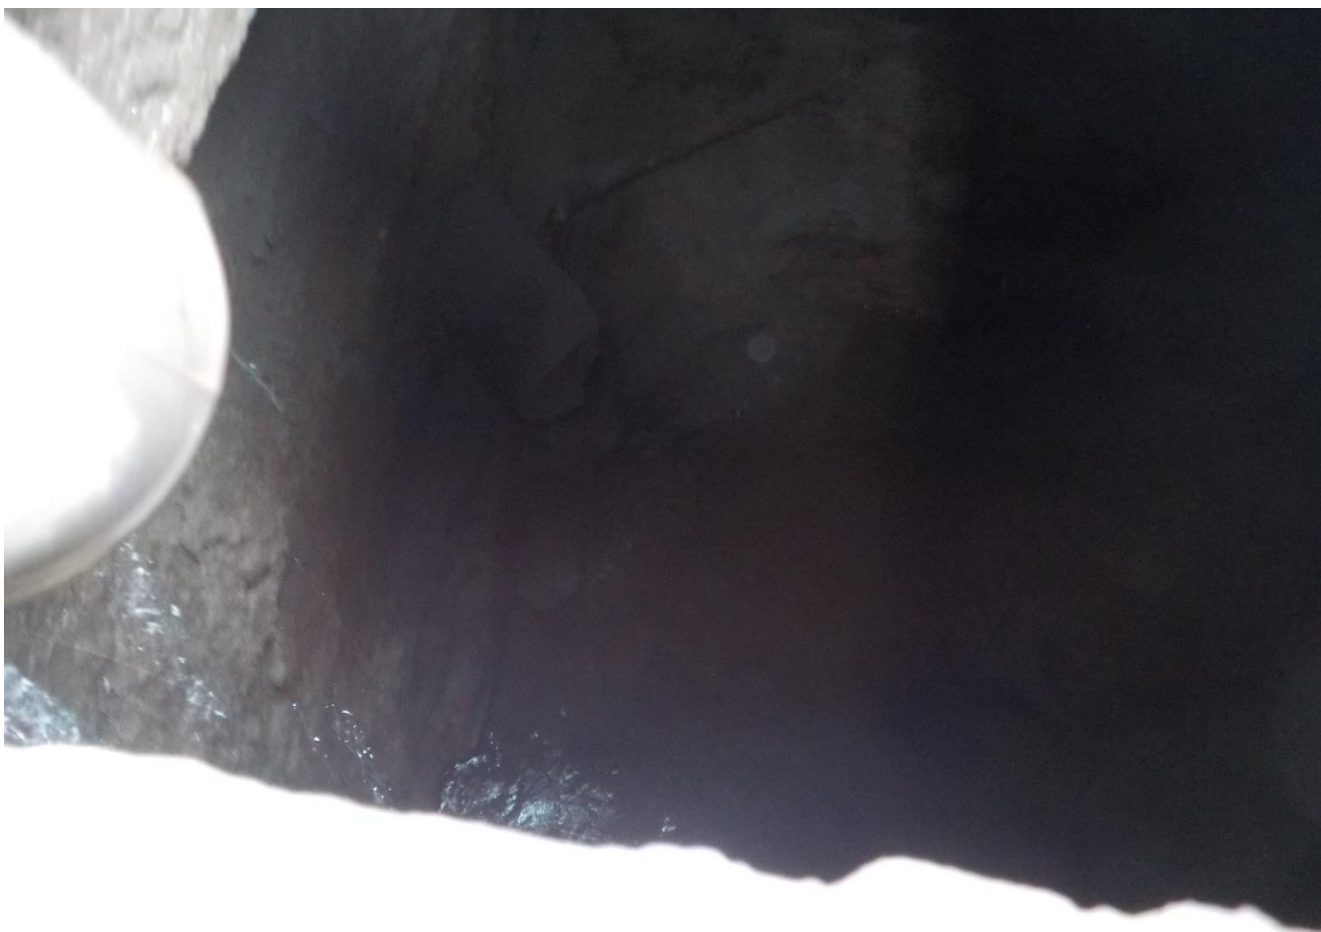
Photo 102. (DSCN0284) This photo shows a portion of the interior of “sump 13.” Water is visible trickling into the pit through a pipe from Kiln 2 (see Photos 99 and 100). Note also, the ends of other pipes are visible inside “sump 13.”

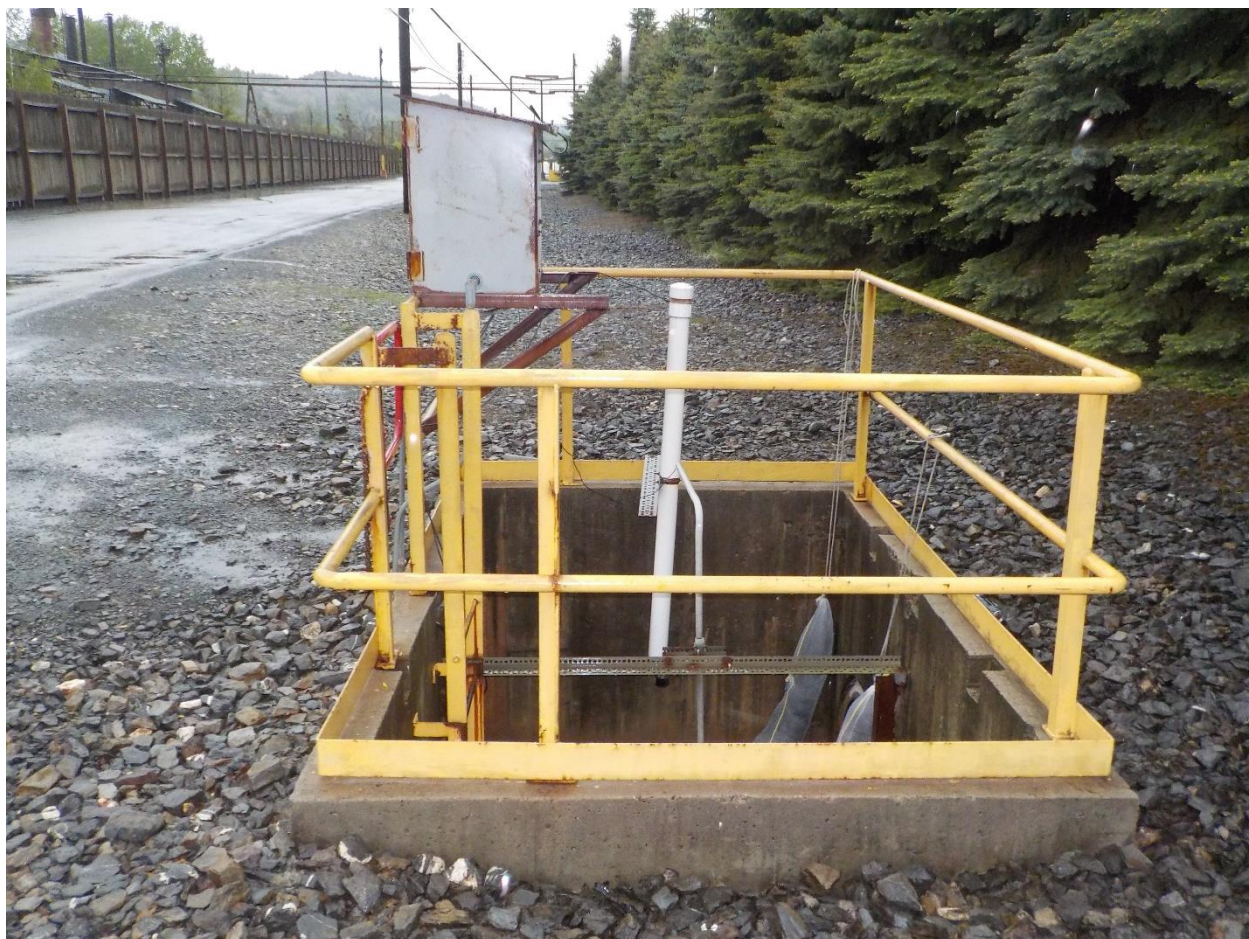
Photo 103. (DSCN0297) This photo looks eastward down the gravel strip parallel to the Facility's northern access road. The gravel is marked as "French drains" on outfall and drainage map in the Facility's 2015 NPDES application. At center foreground is the outfall 004 weir pit.

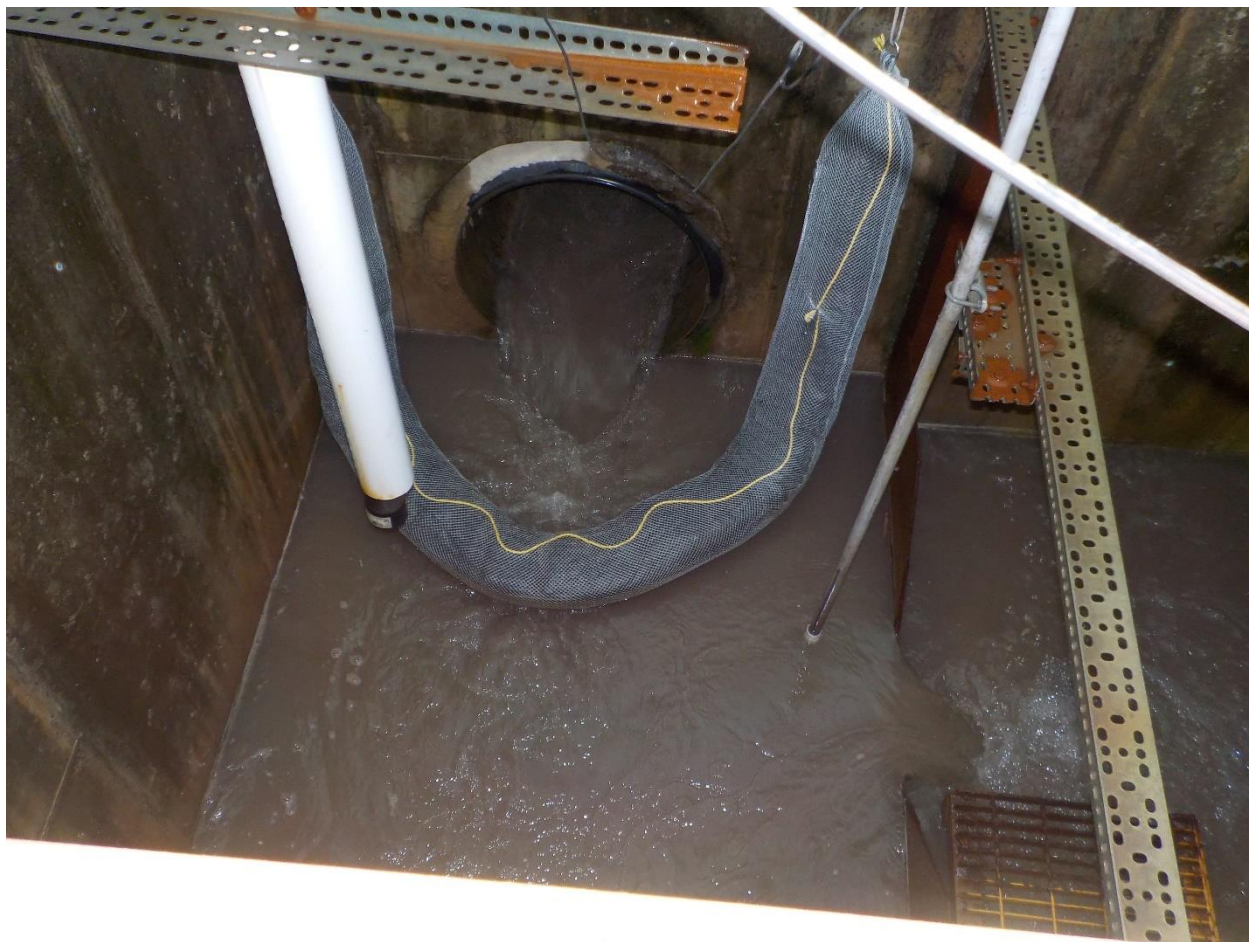
Photo 104. (DSCN0296) This photo, taken approximately 55 minutes after the start of a thunderstorm on 15 May, 2018, shows the effluent over the outfall 004 weir. Note, the water is brown and clarity is poor to due high suspended sediment load in the “first flush” of storm water runoff. See Photo 105 for a comparison of these “first flush” conditions to effluent conditions approximately 16 hours later.

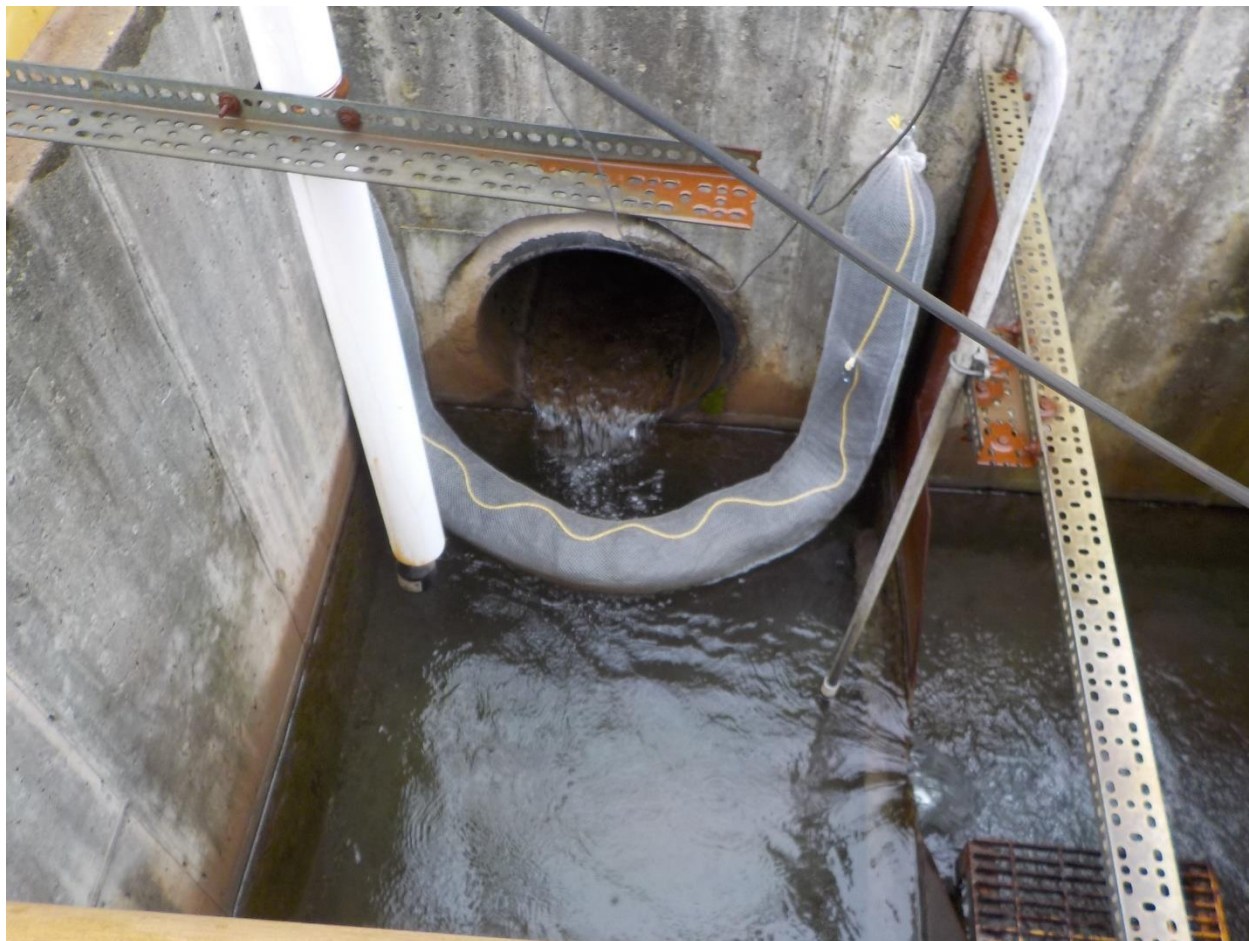
Photo 105. (DSCN0306) This photo, taken on the morning of 16 May, 2018, approximately 16 hours after the May 15th thunderstorm, shows the effluent over the outfall 004 weir. Note, the water is clear. See Photo 104 for a comparison of these conditions to the “first flush” effluent conditions immediately after a storm.

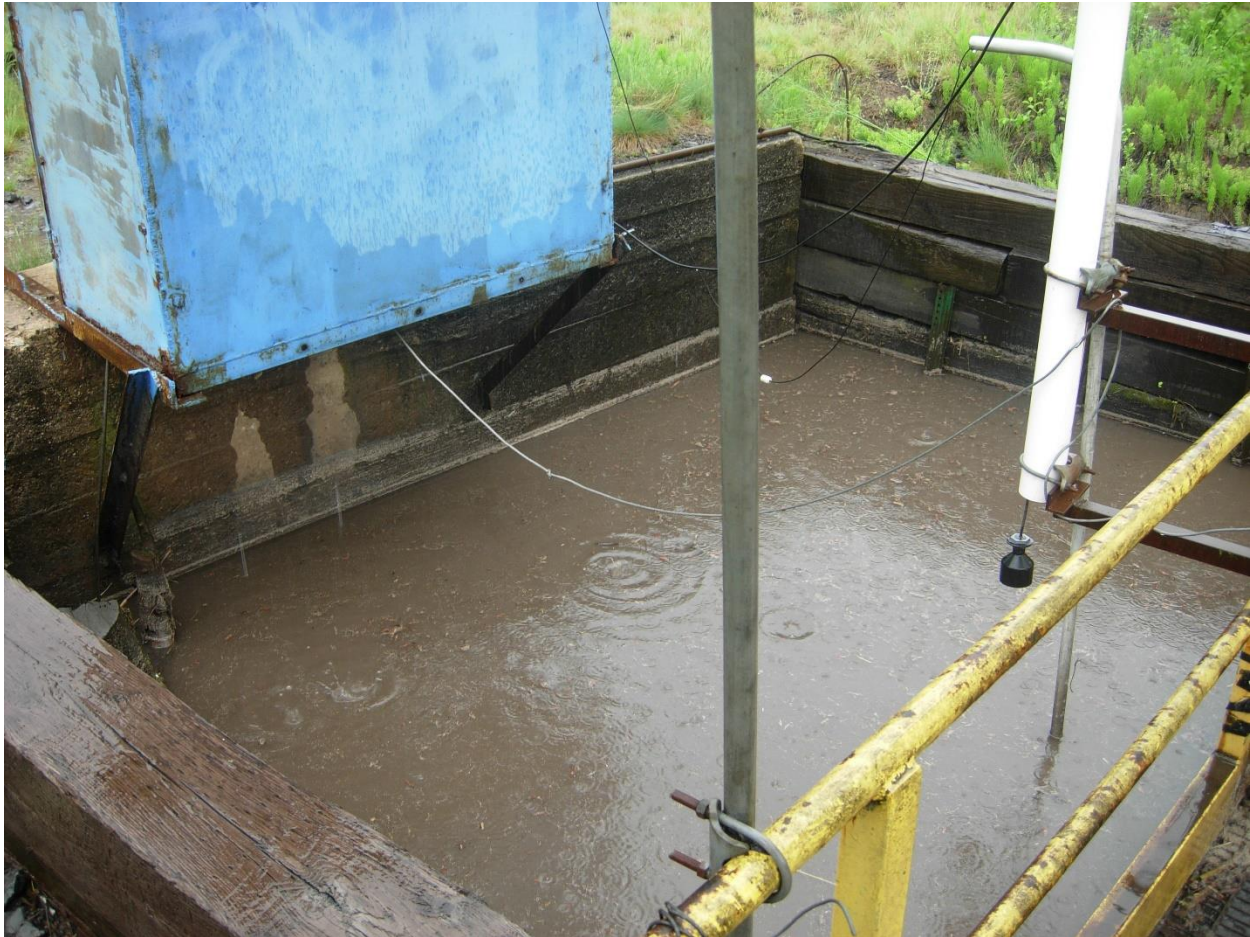
Photo 106. (DSCN0262; NIKON COOLPIX P4) This photo shows the outfall 005 weir box. Note, there are two booms placed in the drainage channel downstream of the weir. See also Photo 107.

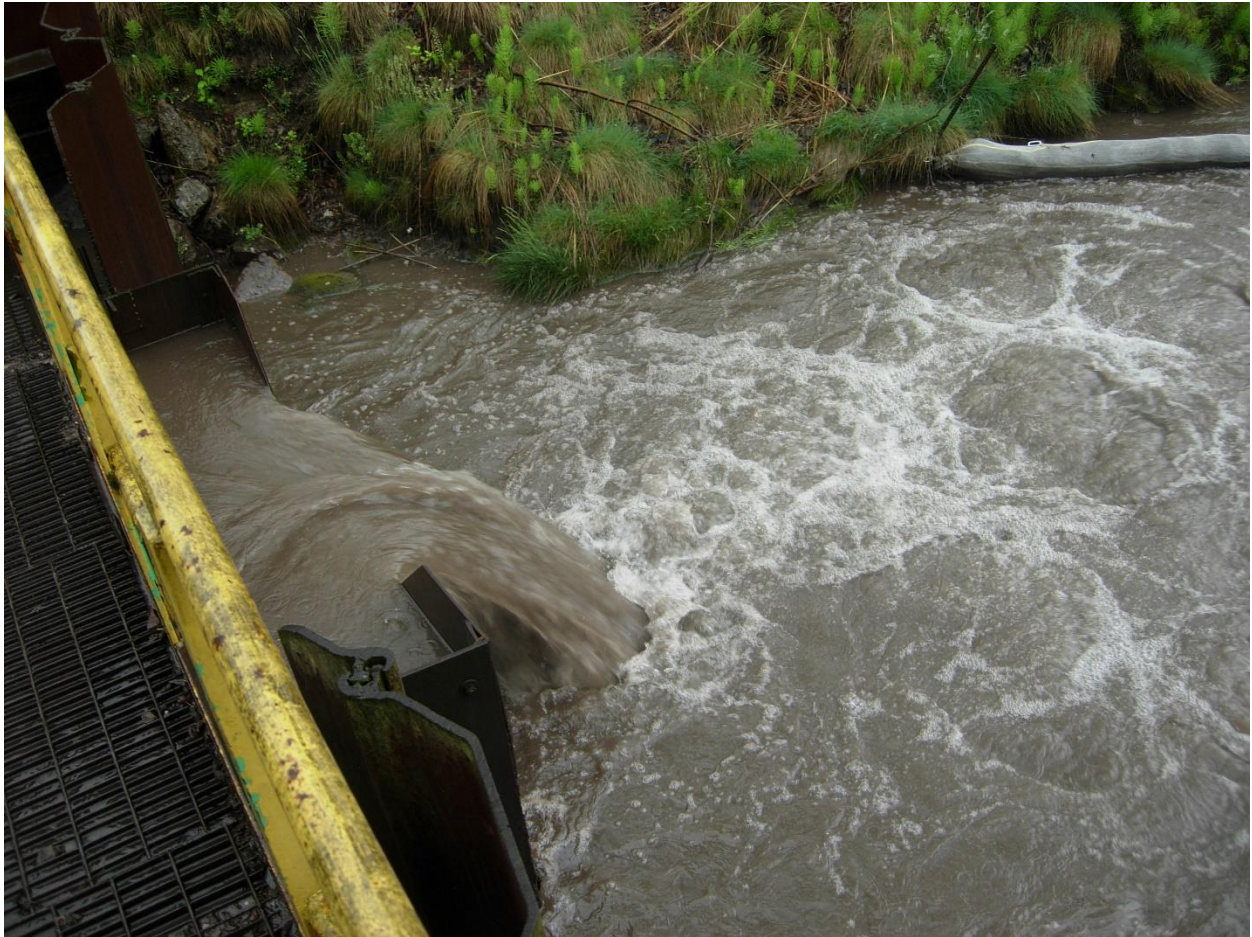
Photo 107. (DSCN0264; NIKON COOLPIX P4) This photo, taken during rainy weather, shows the outfall 005 weir. See also Photo 106.

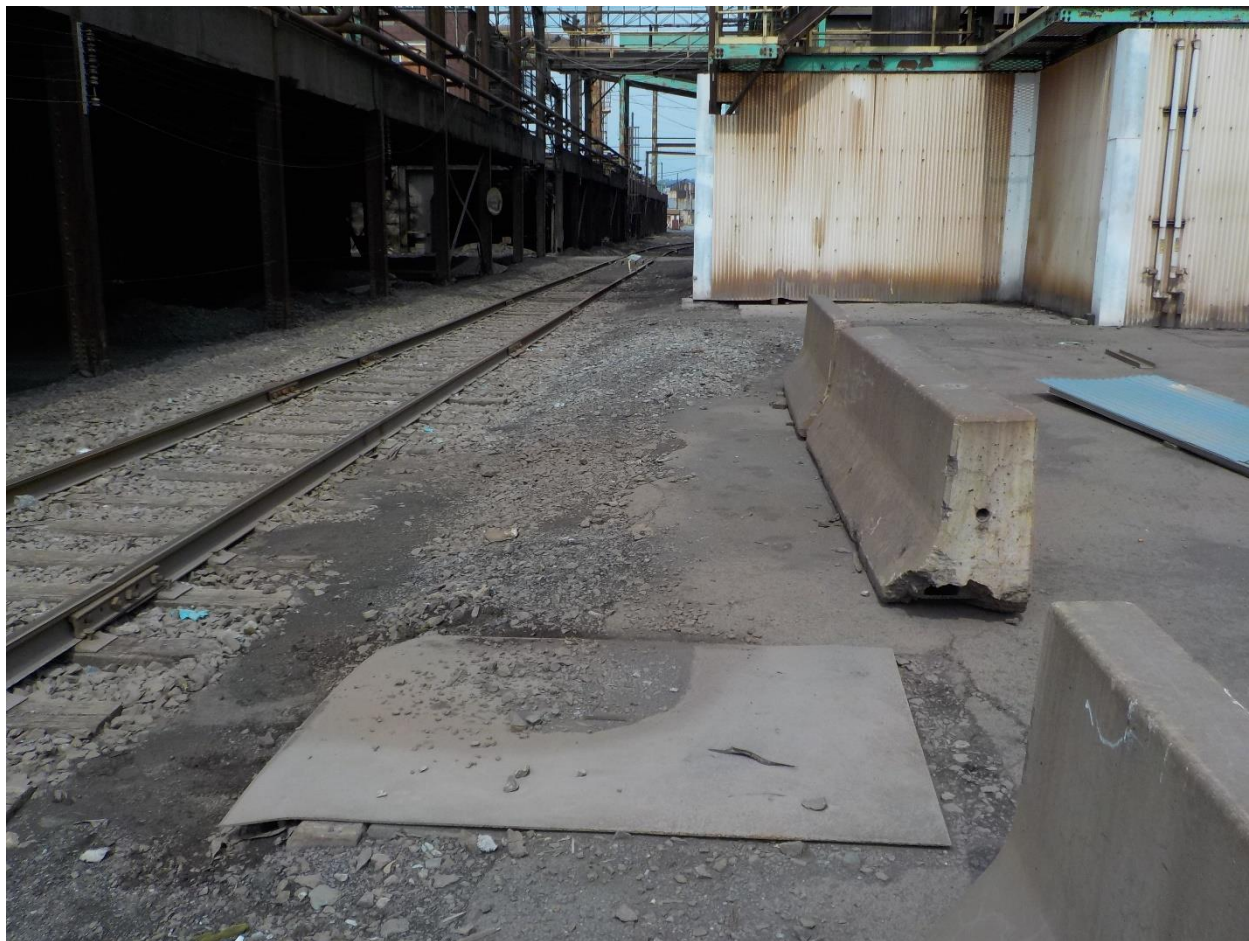
Photo 108. (DSCN0263) This photo looks eastward down the railroad bed immediately north of the kilns. In the foreground, the metal plate covering “sump 11” is visible. Note, this feature is not shown on the Facility’s NPDES outfall and drainage map. See also Photo 109.

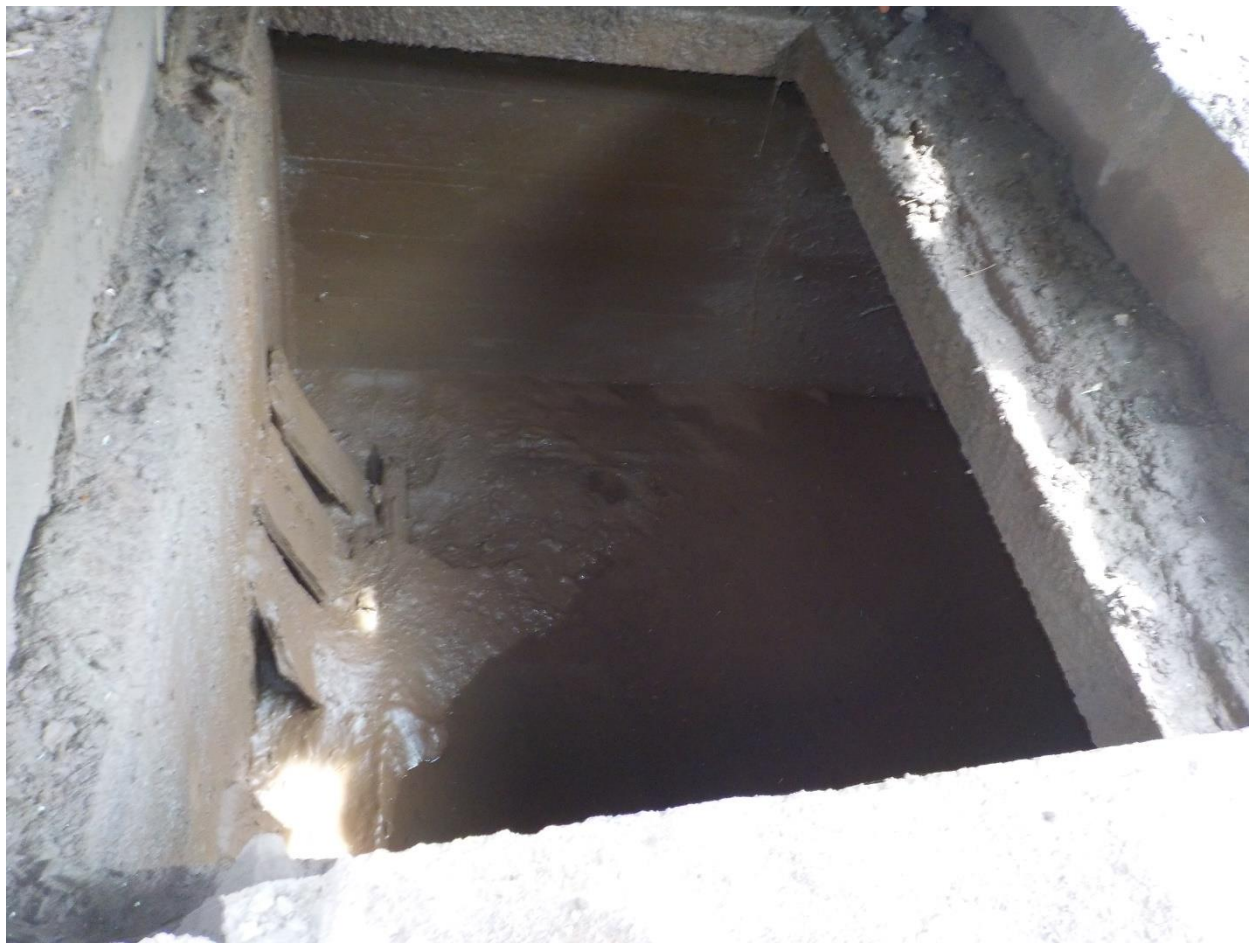
Photo 109. (DSCN0261) This photo shows a portion of the interior of “sump 11.” Note, brown, fine-grained material is accumulated in the sump. See also Photo 108.
